Structural Health Monitoring of a Bonded Composite Patch Repair on a Fatigue-Cracked F-111C Wing

DSTO-RR-0335

A large fatigue crack in the wing skin of an Australian Defence Force F-111C aircraft was repaired with an adhesively bonded boron/epoxy fibre composite patch. The patch prevented further growth of the crack for 670 flying hours.

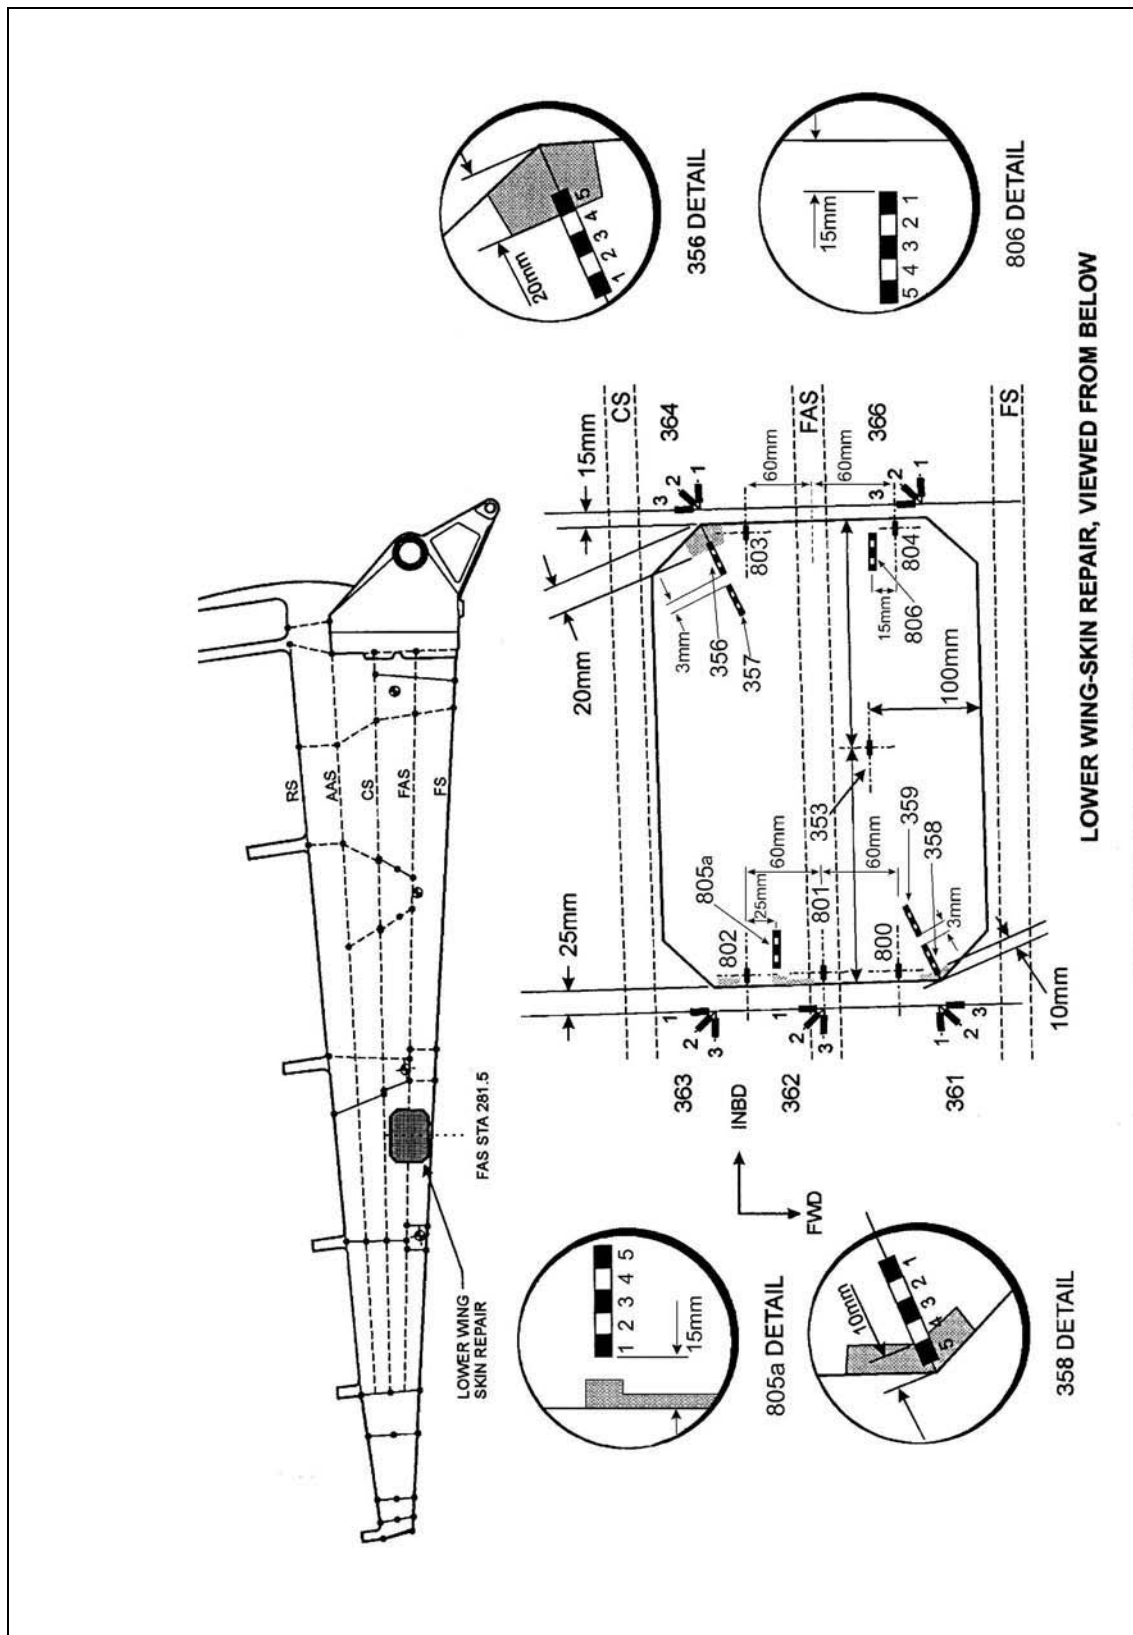
Most of the strain measurements on the A15-5 wing skin and patch were made using single or strip gauges, oriented as indicated in Figure 20 and Figure 21. Strain measurements on the patch were obtained initially at block 6 from strain gauges attached to the areas shown in Figure 20. At block 12 some of these gauges were replaced and extra gauges added, as shown in Figure 21; this figure also indicates the location and size of the disbonds detected by NDI.

Figure 21 Location of strain gauges used on the patch and parent structure from block 12, also showing, schematically, the position and nominal size of some of the disbonds detected by NDI

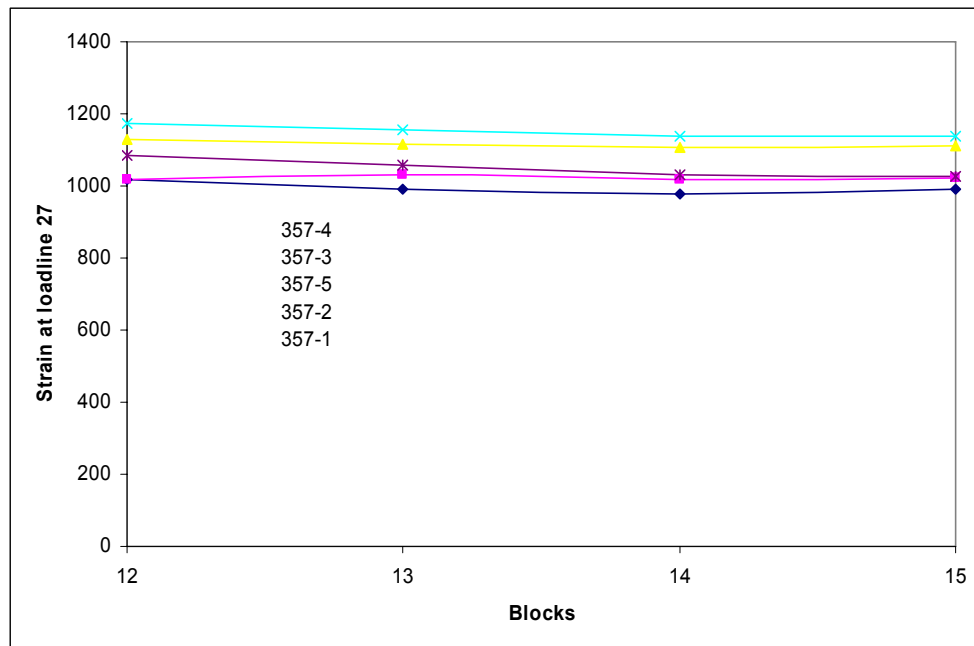
- Strip-gauge 357, Figure 27
 - This strip gauge is further into the patch than 356, so as expected indicates no disbonding, in agreement with the lack of damage found by NDI in this region, see Figure 13.

Figure 27: Strain versus block number for strip-gauge 357 for Blocks 12 to 15; the relevant skin gauge location is gauge 364

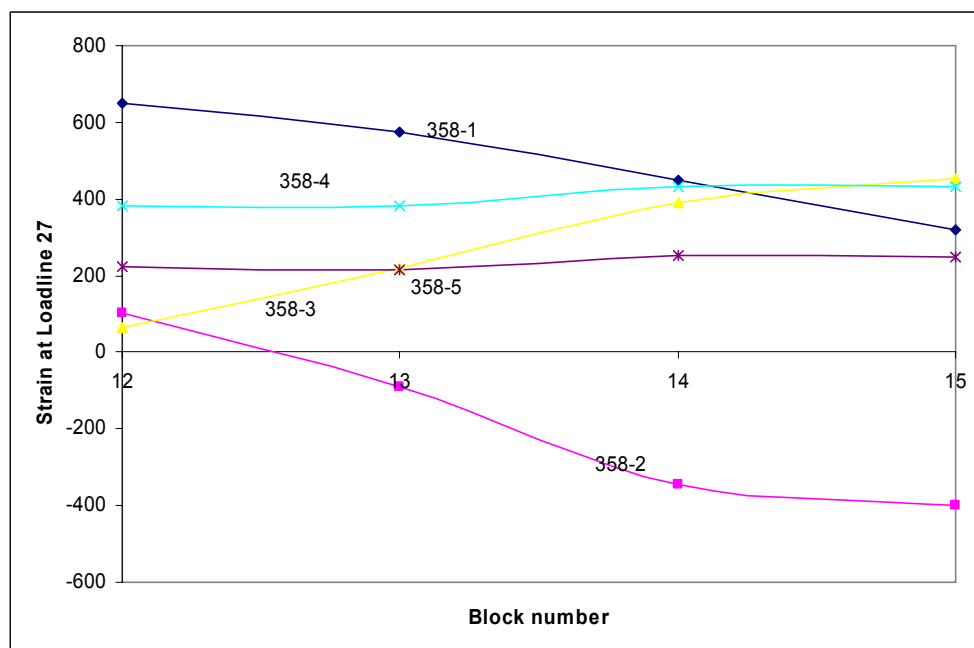
- Strip-gauge 358, Figure 28
 - This strip gauge provides somewhat confusing information. The gauges are clearly located in a disbonded region and there is indication from some of the gauges that the damage is slowly growing. Gauges 358-3 and 358-4 appear to be giving anomalous strain readings only 358-1 indicates possible further disbond growth. However, gauge 5 would be expected to provide the lowest strain readings, not gauge 2. NDI indications from this region are provided in Figure 15.

Figure 28: Strain versus block number for strip-gauge 358 for Blocks 12 to 15; the relevant skin gauge location is gauge 361

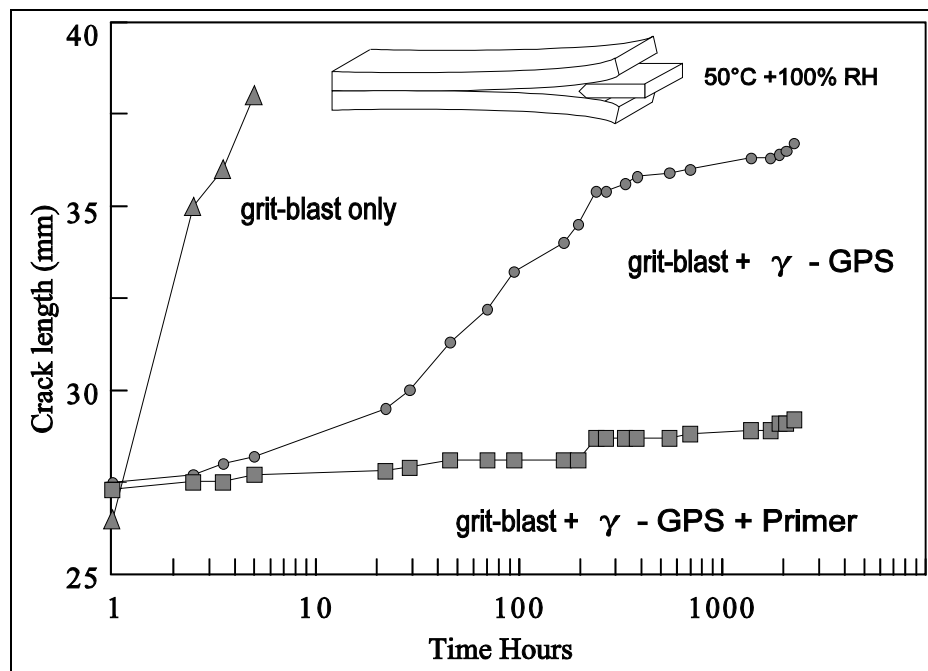
Figure 36 shows results from the Boeing wedge test in which aluminium alloy strips are bonded together with the adhesive of interest, in this case FM73, following application of the candidate pre-bonding surface treatment. A wedge is then driven between the strips to a prescribed distance and the specimen exposed to 50 ° C in 100% condensing humidity environment. The growth and locus of the disbonding crack are noted. As clearly shown in this figure use of the adhesive primer with the silane process has a very significant effect on reducing growth of the disbonding crack compared to the use of silane process alone.

Figure 36: Plots of crack growth versus time for Boeing-wedge-test specimens (illustrated inset) made of 2024T3 aluminium and subjected to the surface treatments indicated, prior to bonding with adhesive FM73, taken from Reference [1].
